# RICHARD CROOKES

## MONTHLY SITE ENVIRONMENTAL AUDIT

### 6 HASSALL STREET, PARRAMATTA.

12<sup>th</sup> January 2021

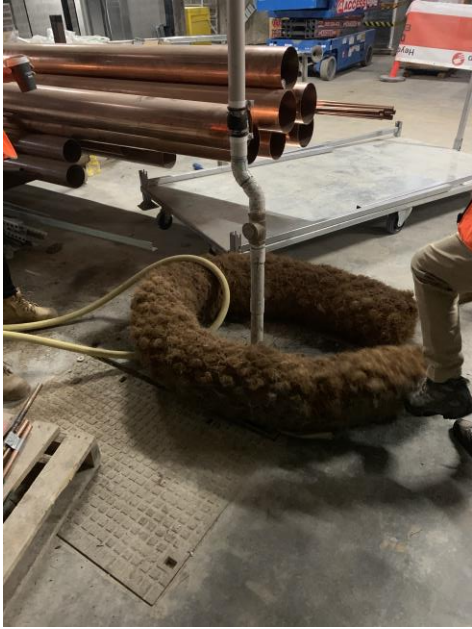
<ul style="list-style-type: none"> <li><i>Sediment control around stormwater tank</i></li> </ul>		
Item 2	<i>Gas bottles chained</i>

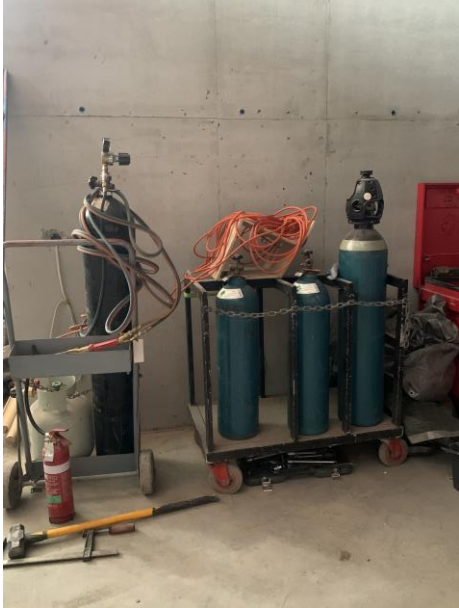
<ul style="list-style-type: none"> <li><i>Gas bottles chained on site</i></li> </ul>

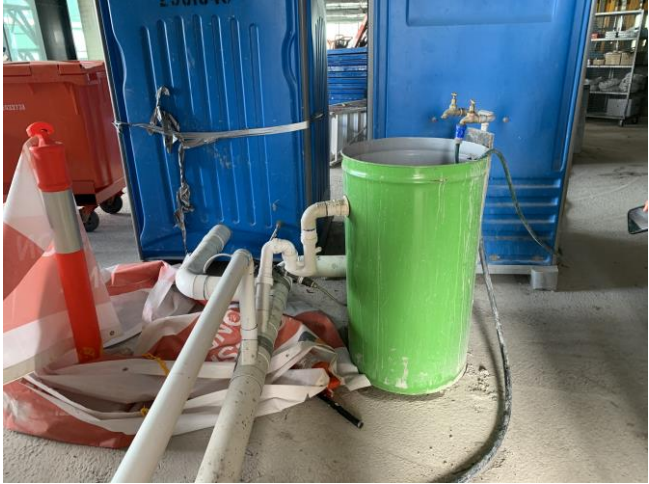
<p>Item 3</p>	<p>Extra sediment drum required</p>

<ul style="list-style-type: none"> <li>• <i>Level 11 Extra sediment drum required</i></li> </ul>		
<p>Item 4</p>	<p>Concrete cutting generating air pollution</p>

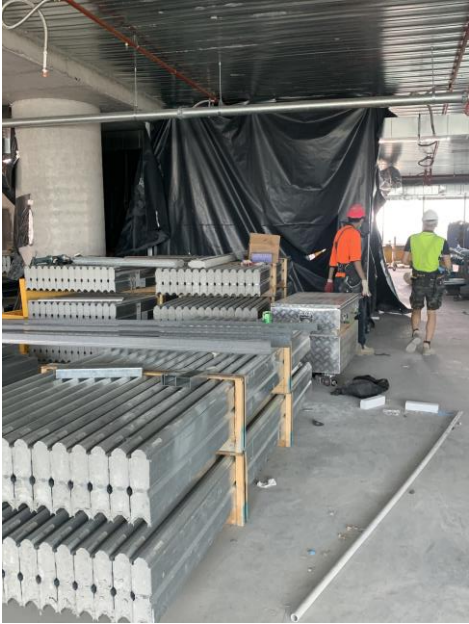
<ul style="list-style-type: none"> <li>• <i>Sealed room required for concrete cutting; Holes evident in the plastic need to be sealed</i></li> </ul>

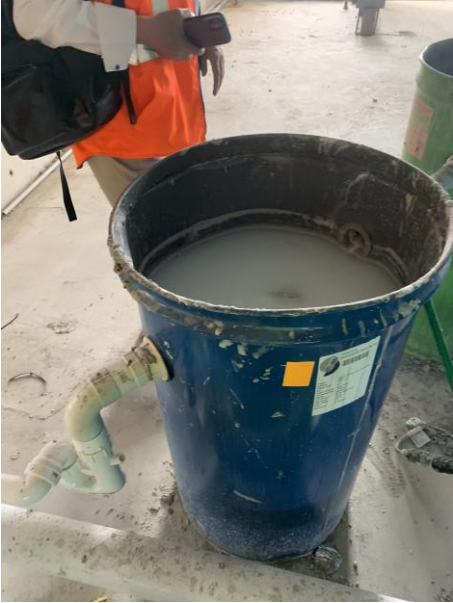
Item 5	Sediment wash out

- *Level 9 Sediment wash out needs replacing*

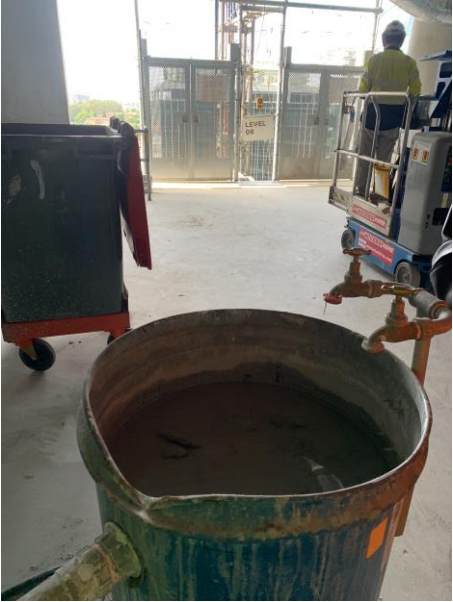
Item 6	Sediment washout

- *Level 8 Sediment wash out needs replacing*

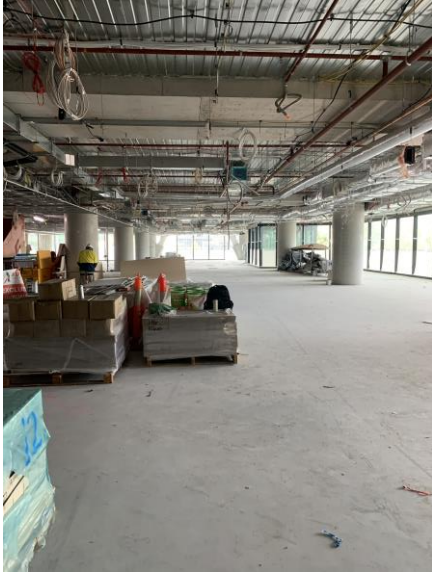
<p>Item 7</p>	<p>Clean floors</p>

<ul style="list-style-type: none"> <li>• Floors well cleaned reducing generation of dust</li> </ul>		
<p>Item 8</p>	<p>Painters Washout</p>

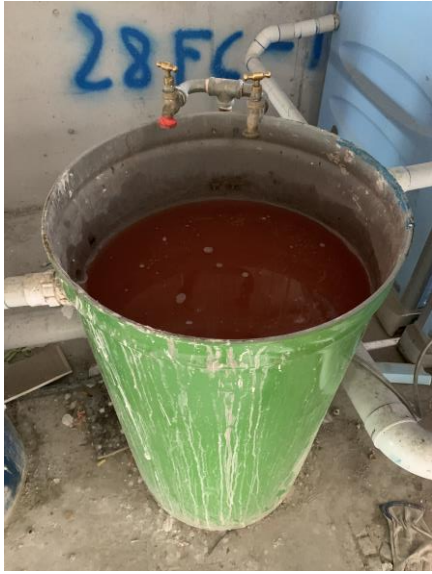
<ul style="list-style-type: none"> <li>• Level 8 Painters require a washout system to remove painter's washout</li> </ul>

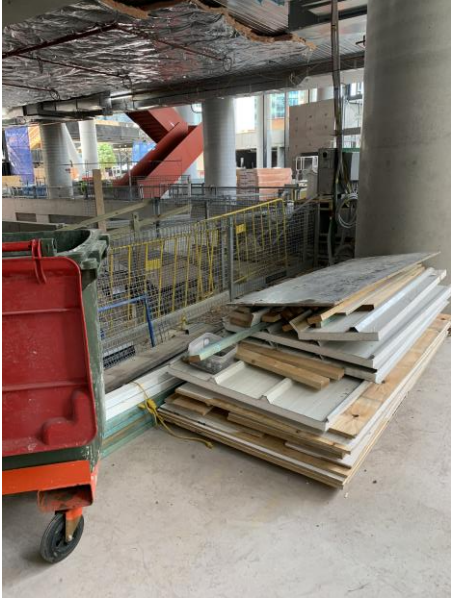
Item 9	Packaging

<ul style="list-style-type: none"> <li>• <i>Packaging removed by Sub Contractors</i></li> </ul>		
Item 10	Water in Diesel Bund

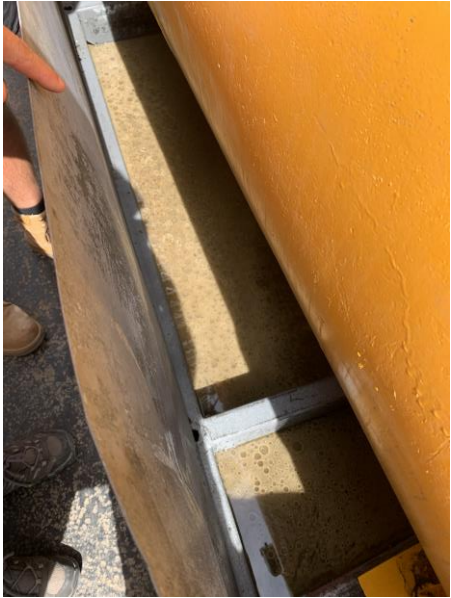
<ul style="list-style-type: none"> <li>• <i>Water allowed to evaporate</i></li> </ul>
