RICHARD CROOKES MONTHLY SITE ENVIRONMENTAL AUDIT

6 HASSALL STREET, PARRAMMATTA.

3rd JUNE 2021

6 HASSALL ST, PARRAMATTA SITE ENVIRONMENTAL AUDIT TABLE OF CONTENTS

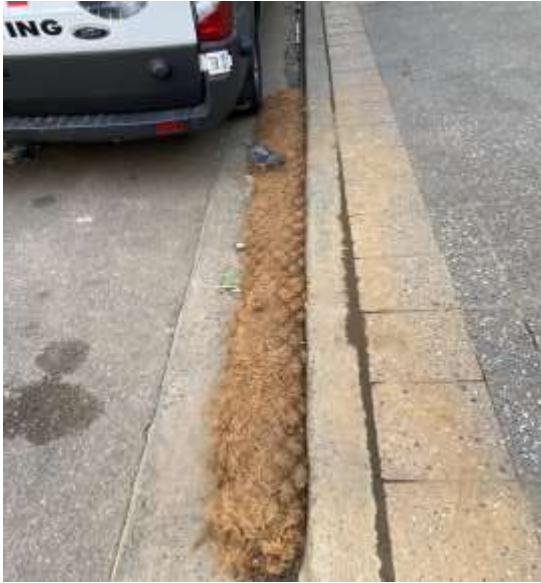
PHOTOGRAPHIC RECORD		
Item	Observations	Photographic Record
Item 1	External Works

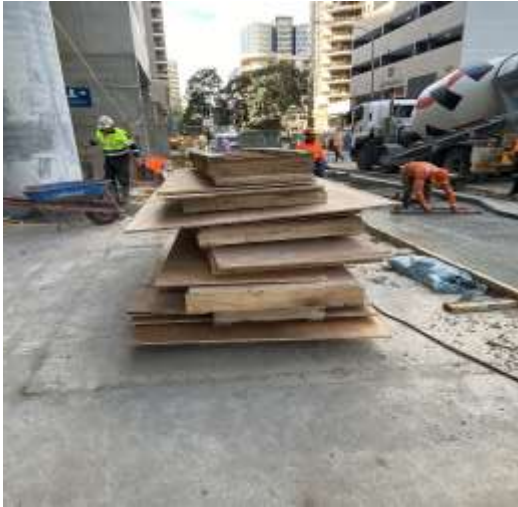
Item 2	Packaging

<ul style="list-style-type: none"> • <i>Packaging returned to the supplier</i>

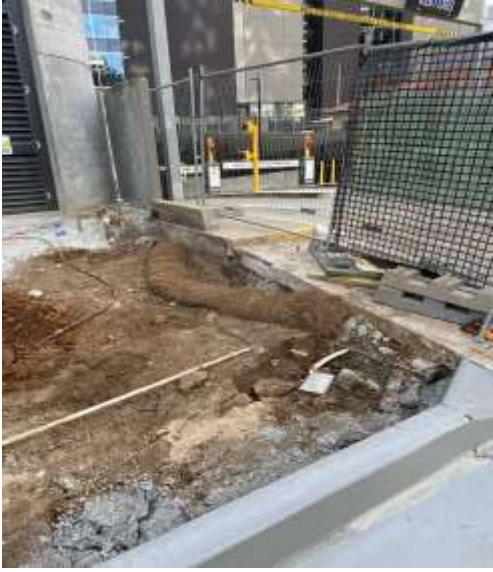
Item 3	Sediment Control

<ul style="list-style-type: none"> • <i>Effective sediment control</i> 		
Item 4	Green Star	 
<ul style="list-style-type: none"> • <i>Green Star Compliant materials</i>

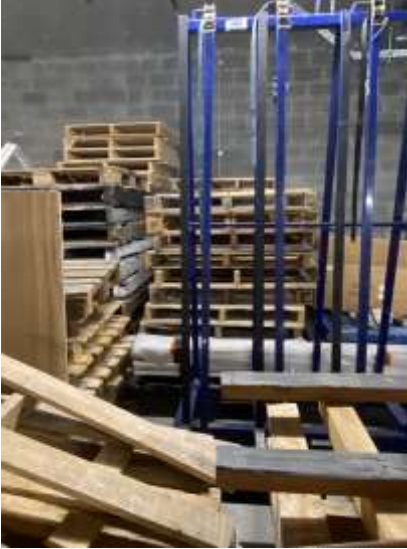
Item 5	Waste

<ul style="list-style-type: none"> • <i>Pallets for reuse</i>

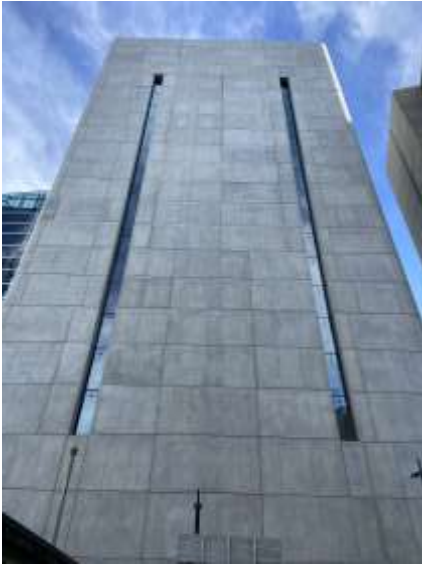
Item 6	Site completion

<ul style="list-style-type: none"> • <i>Completion of external works</i>
