RICHARD CROOKES MONTHLY SITE ENVIRONMENTAL AUDIT

6 HASSALL STREET, PARRAMMATTA.

8^h April 2021

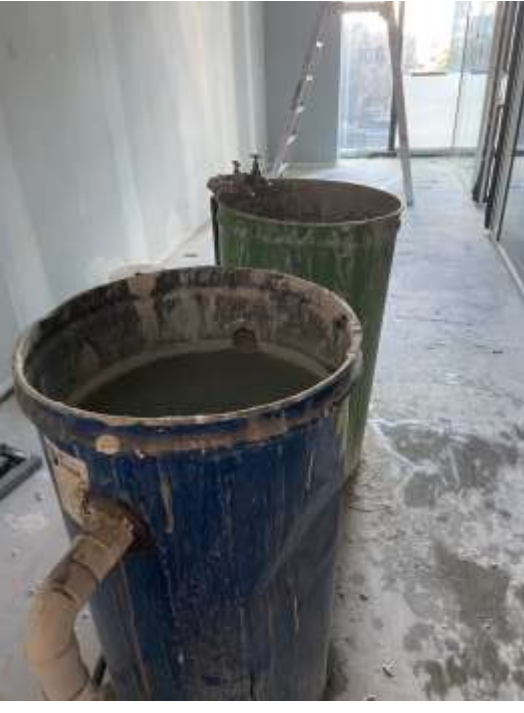
PHOTOGRAPHIC RECORD		
Item	Observations	Photographic Record
Item 1	Drums need replacement on levels 3 and 9

<ul style="list-style-type: none"> <i>Sediment drums need replacing on levels 3 and 9</i> 		
Item 2	<i>Slurry run off</i>

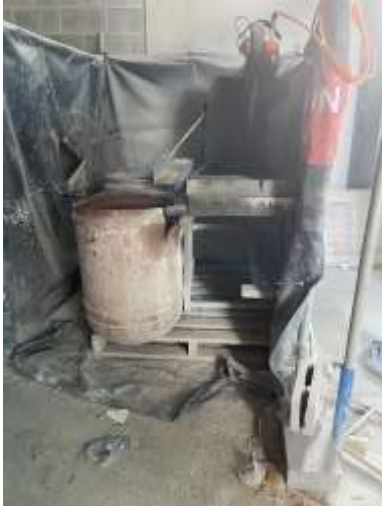
<ul style="list-style-type: none"> <i>Brick saw requires bunding to prevent slurry run off</i>

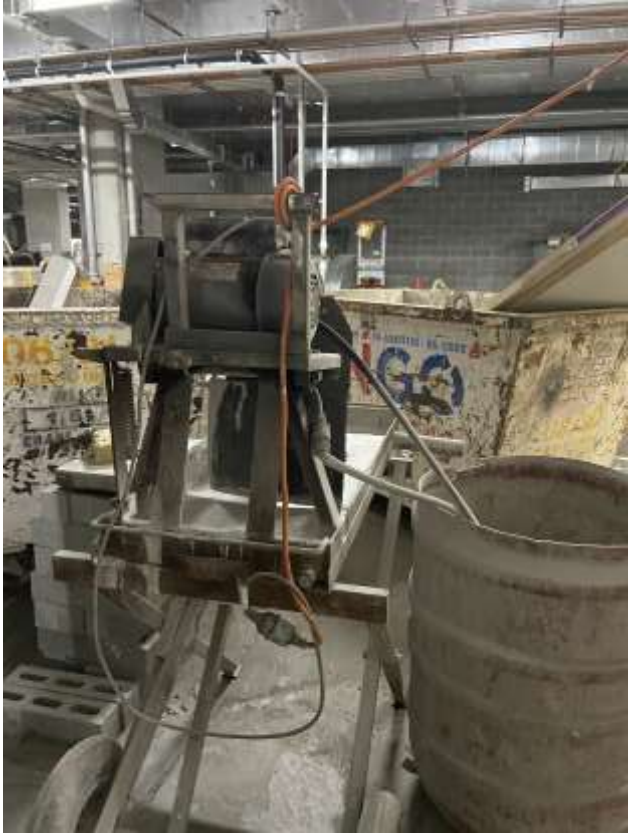
<p>Item 3</p>	<p>Un banded brick saw</p>

<ul style="list-style-type: none"> • <i>Brick saw required bunding to prevent slurry run off</i> 		
<p>Item 4</p>	<p>Road clean</p>

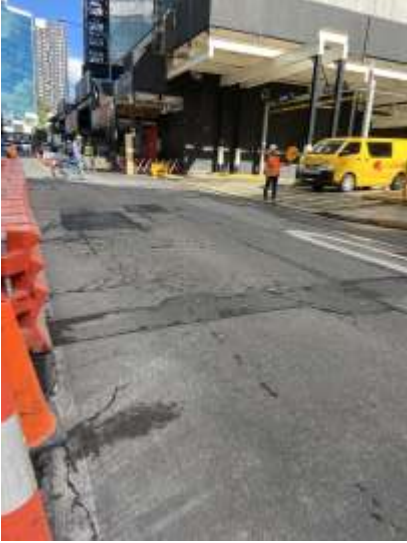
<ul style="list-style-type: none"> • <i>Road well swept and clean</i>

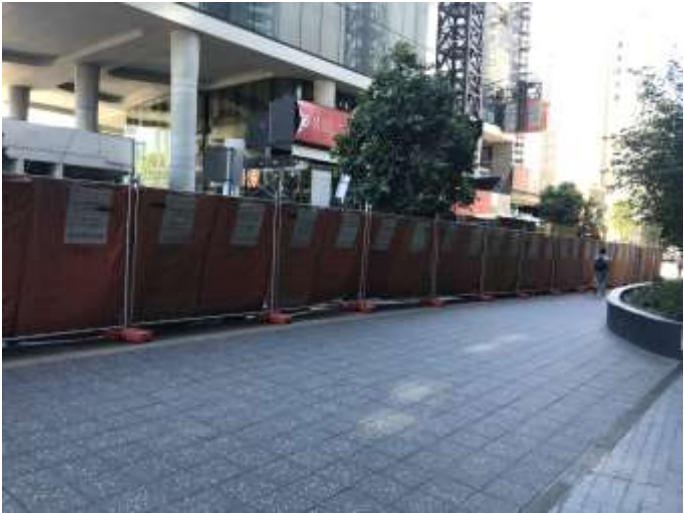
Item 5	Erosion and Sediment Control

- *Established Erosion and Sediment Control during stormwater works*

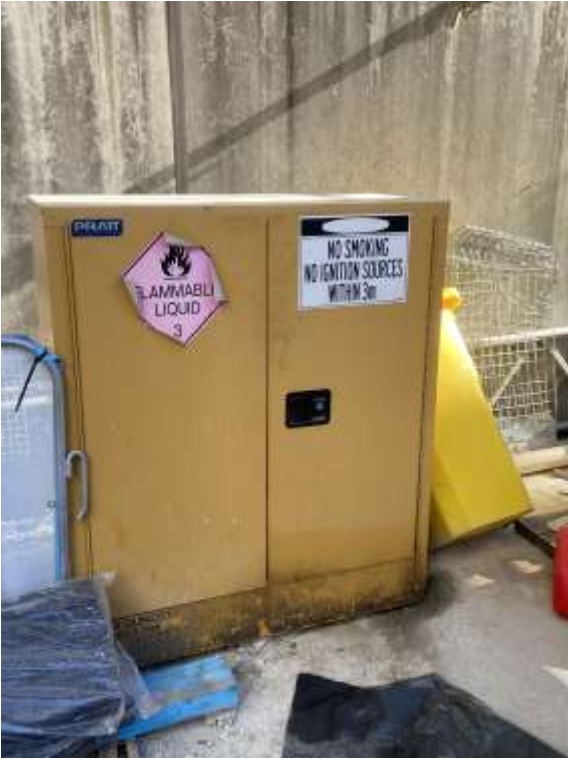
Item 7	Fuel Storage container

- *Fuel storage area adequate*

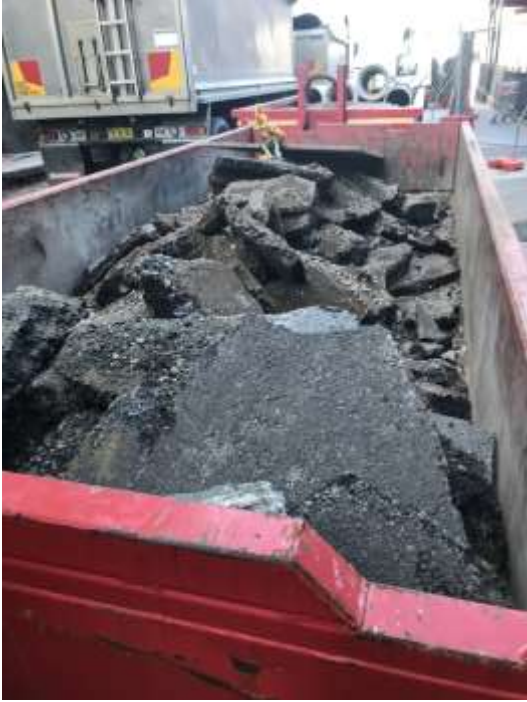
Item 8	Asphalt

- *Asphalt removed from stormwater works for recycling*
