RICHARD CROOKES MONTHLY SITE ENVIRONMENTAL AUDIT

6 HASSALL STREET, PARRAMMATTA.

5th May 2021

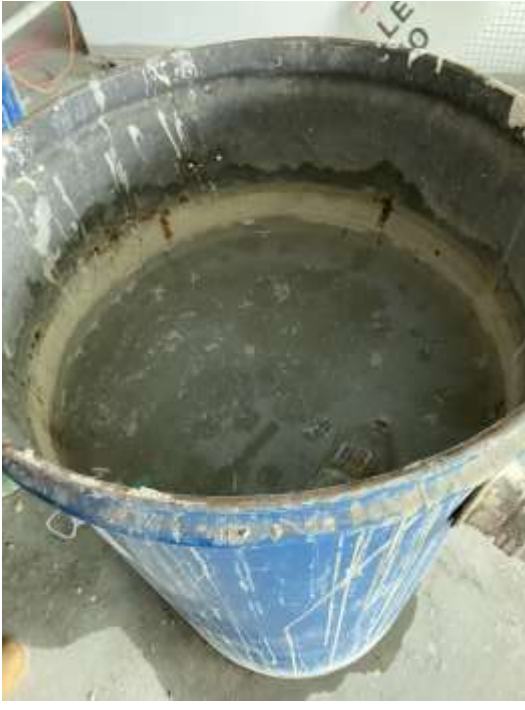
PHOTOGRAPHIC RECORD		
Item	Observations	Photographic Record
Item 1	Drums have been replacement

<ul style="list-style-type: none"> <i>Sediment drums have been need replaced</i> 		
Item 2	<i>Slurry run off</i>

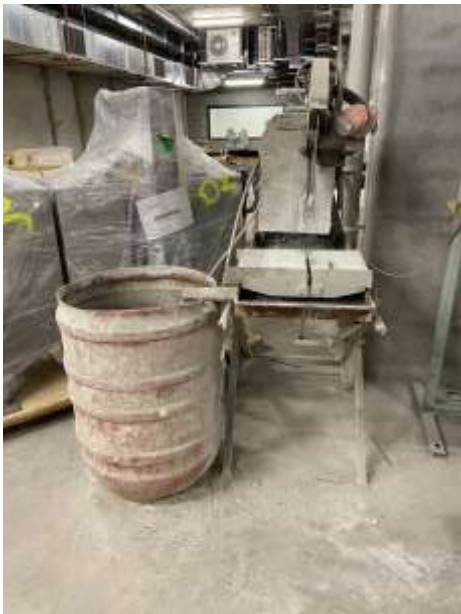
<ul style="list-style-type: none"> <i>Brick saw requires bunding to prevent slurry run off</i>

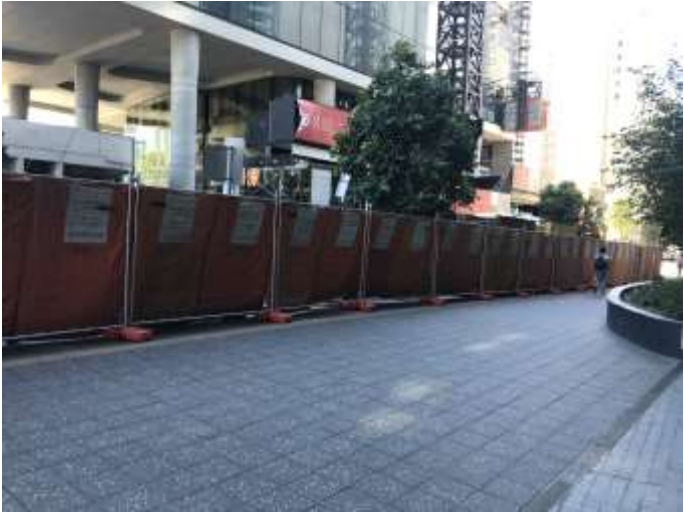
<p>Item 3</p>	<p>Noise and dust control</p>

<ul style="list-style-type: none"> Established Noise and Dust Control during stormwater works 		
<p>Item 4</p>	<p>Decanting area banded</p>

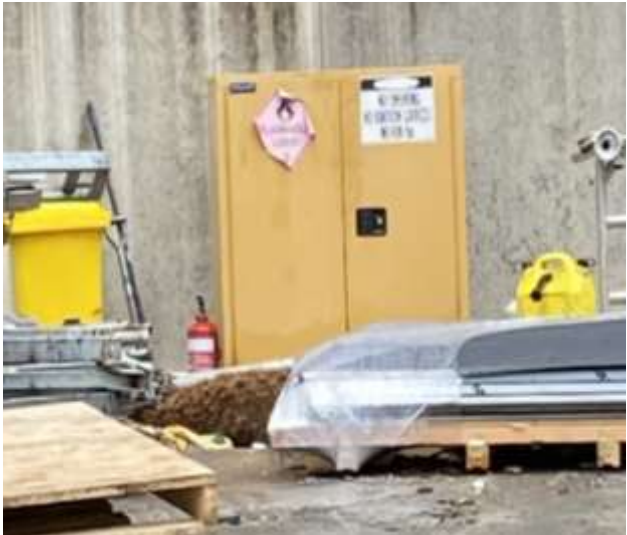
<ul style="list-style-type: none"> Spill kits available and tied in banded area

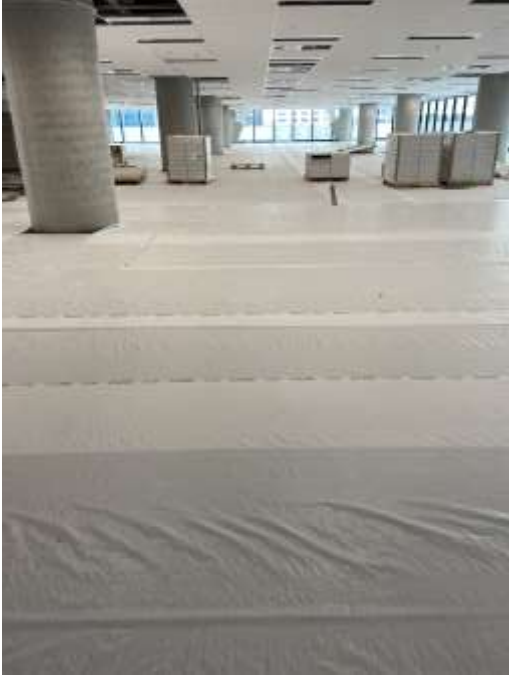
Item 7	Plastic covering to be recycled at end of project

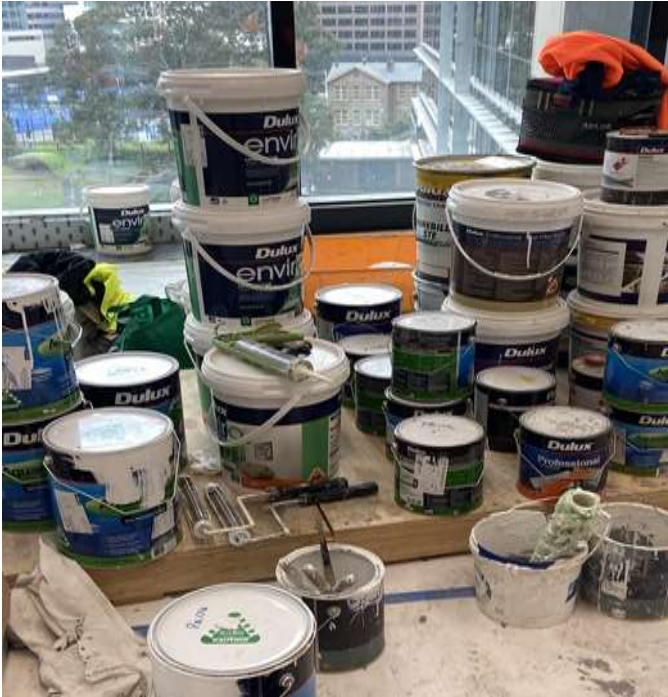
Item 8	Green Star Enviro Paint

<ul style="list-style-type: none">• <i>Enviro Paint and the painters now have a separate washout area</i>

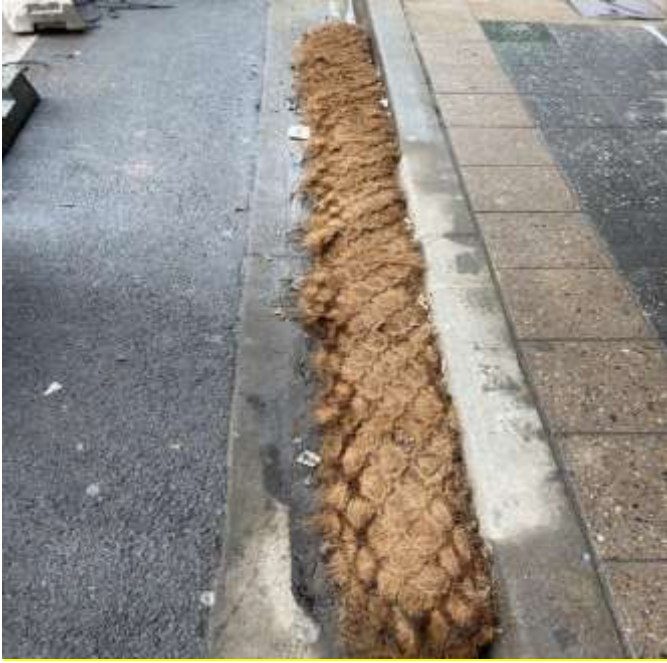
Item 9	Established Erosion and Sediment Control
