MONTHLY SITE ENVIRONMENTAL AUDIT

6 HASSALL STREET, PARRAMATTA.

3rd September 2020

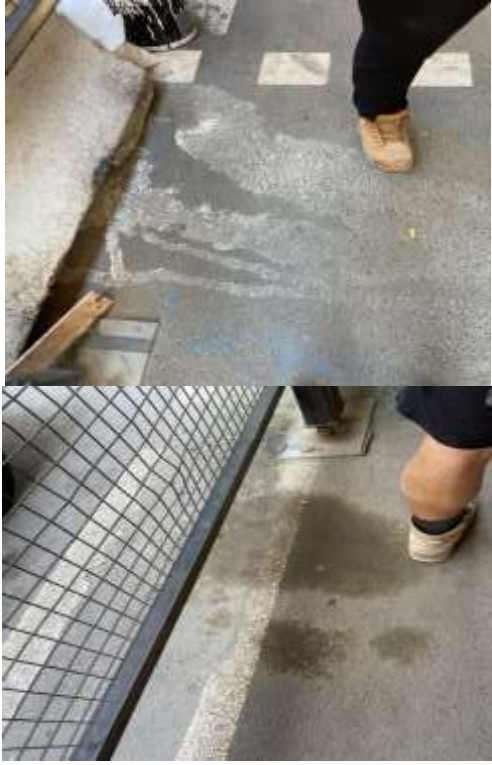
Item	Observations	Photographic Record
Item 1	Diesel stains on road to be cleaned with Enretech

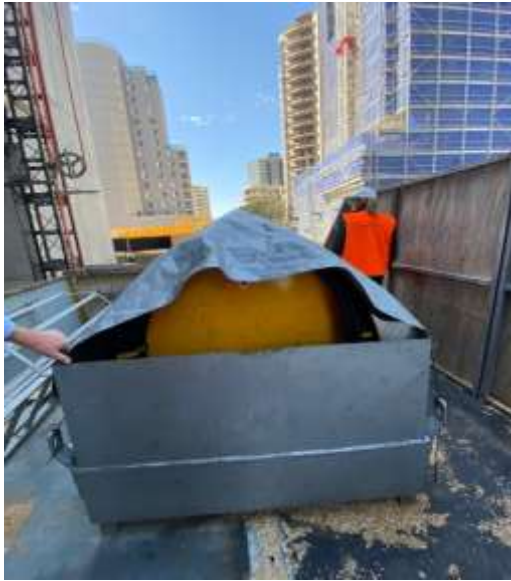
<p><i>Close out date</i></p>		
Item 2	<i>Larger tarp required on diesel drum</i>

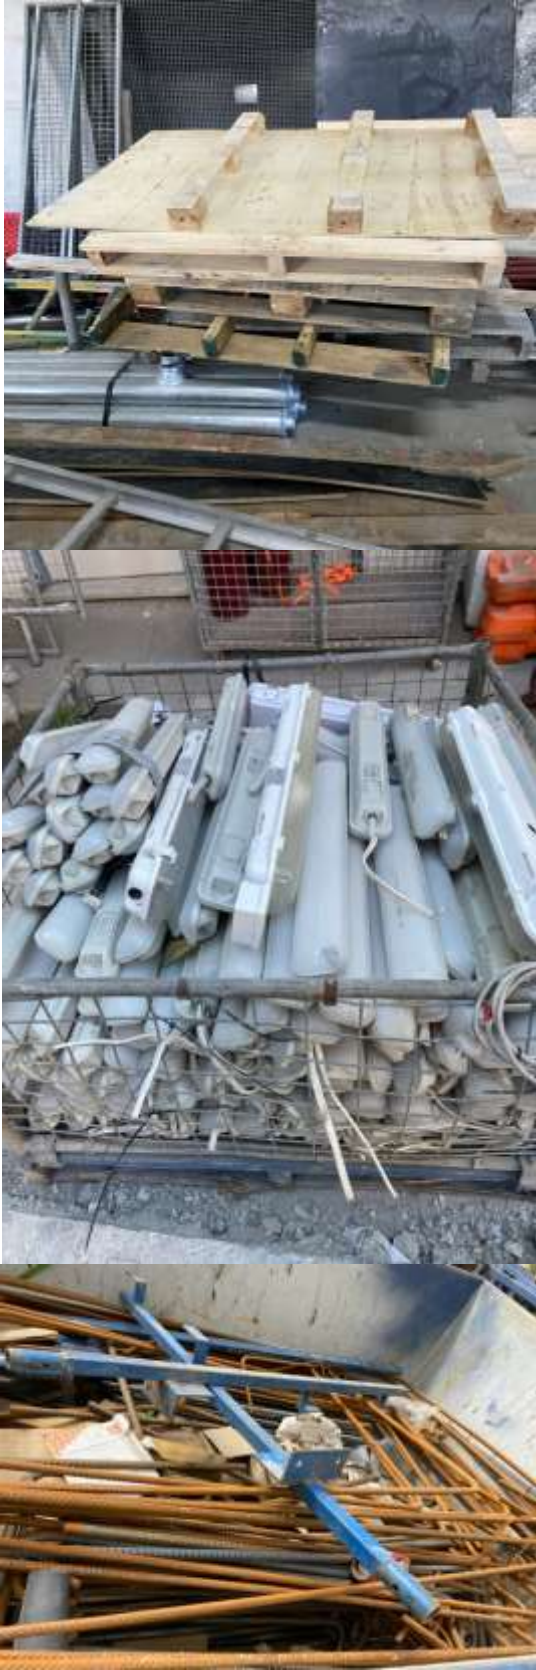
Item 3	Waste Management

<p>The top photograph shows a stack of wooden pallets and a metal pipe. The middle photograph shows a metal cart filled with various types of fluorescent and LED light fixtures. The bottom photograph shows a pile of rebar and other metal construction materials.</p>
<ul style="list-style-type: none">• <i>Materials and lights for reuse on site</i>

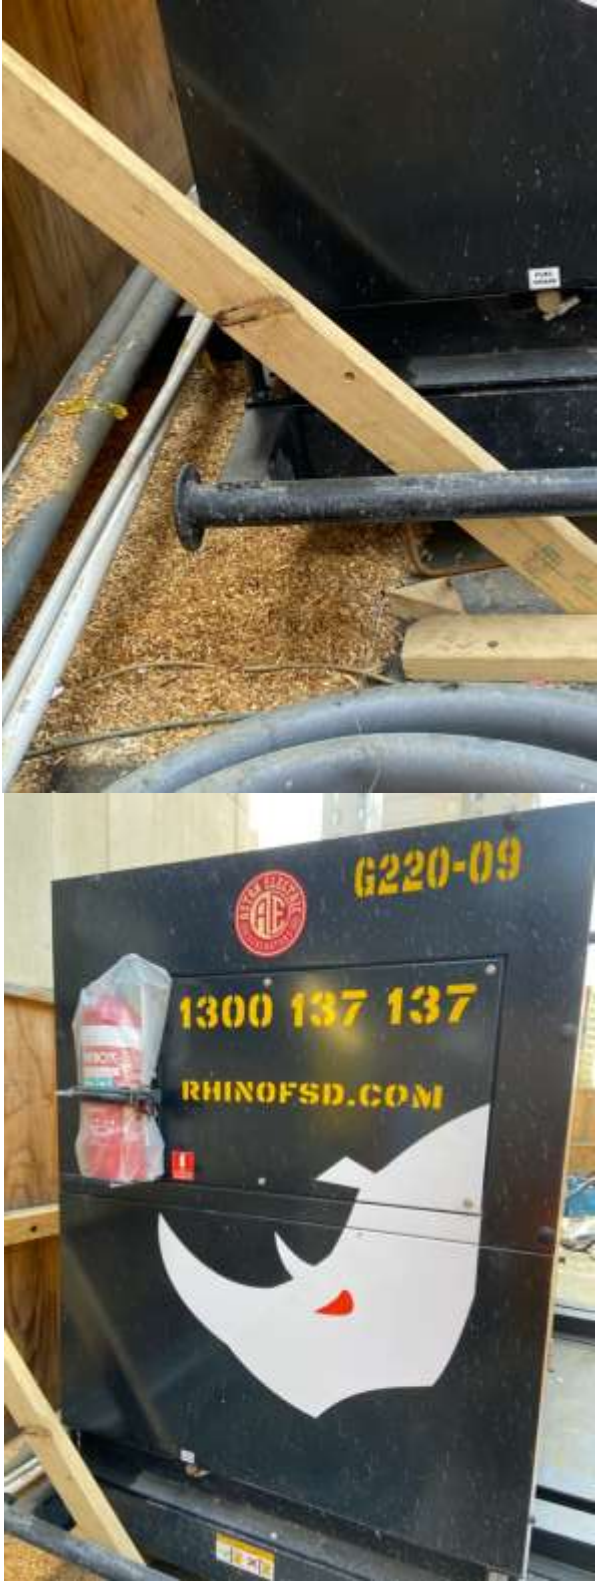
Item 4	<p><i>Small diesel spill on site</i></p> <p><i>Sawdust to be removed as Hazardous Waste</i></p>

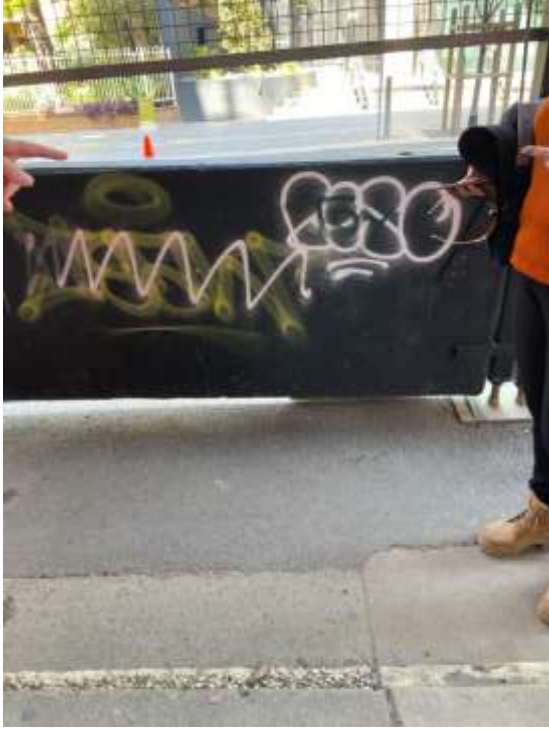
<p>Item 5</p>	<p><i>Graffiti on exterior fences to be cleaned.</i></p>

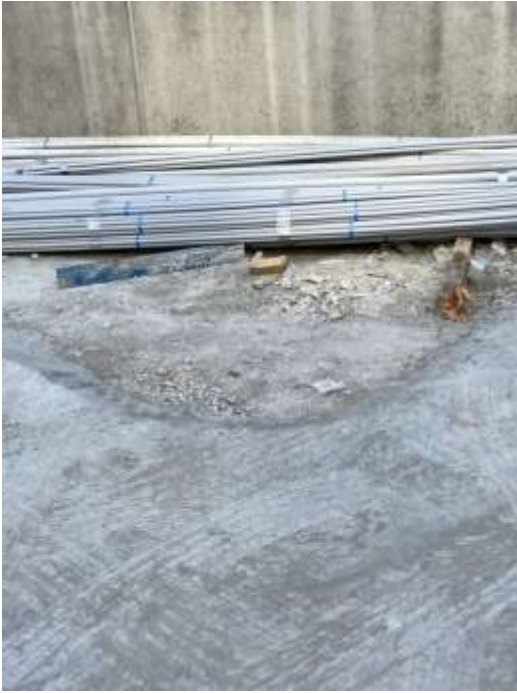
<ul style="list-style-type: none"> • <i>Close out date</i> 		
<p>Item 6</p>	<p>Decanting and Bunding area to be established</p>

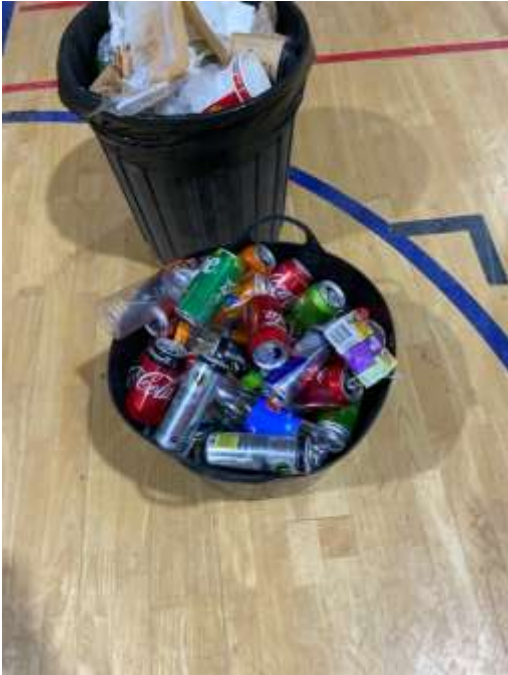
<p>Item 7</p>	<p>Waste Management</p>

<ul style="list-style-type: none"> • <i>Recycling in staff break rooms</i> 		
<p>Item 8</p>	<p><i>Slurry needs to be contained and taken off site and not put in RCC bins</i></p>

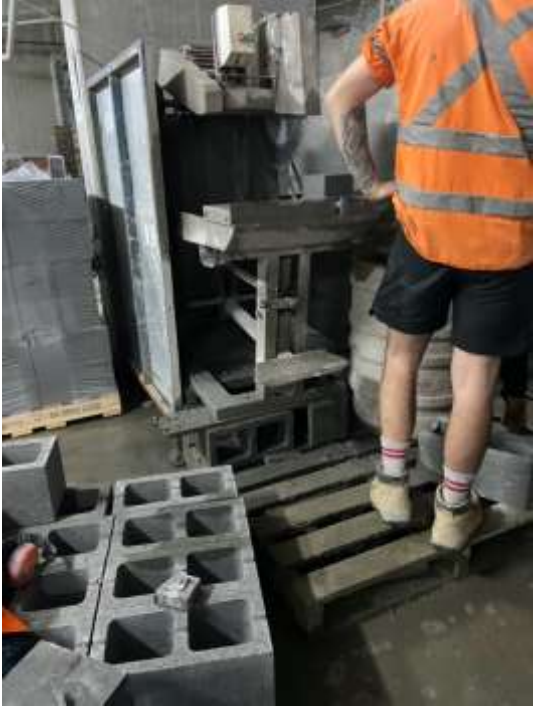
<p>Item 9</p>	<p><i>Brick saw needs to be properly banded to prevent run off</i></p>

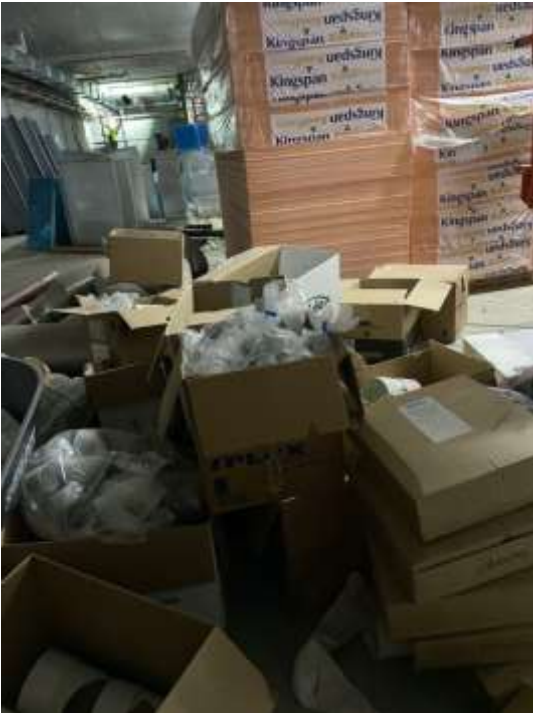
<ul style="list-style-type: none"> • <i>Close out date</i> 		
<p>Item 10</p>	<p><i>Cardboard boxes need to be removed by plumber Management</i></p>

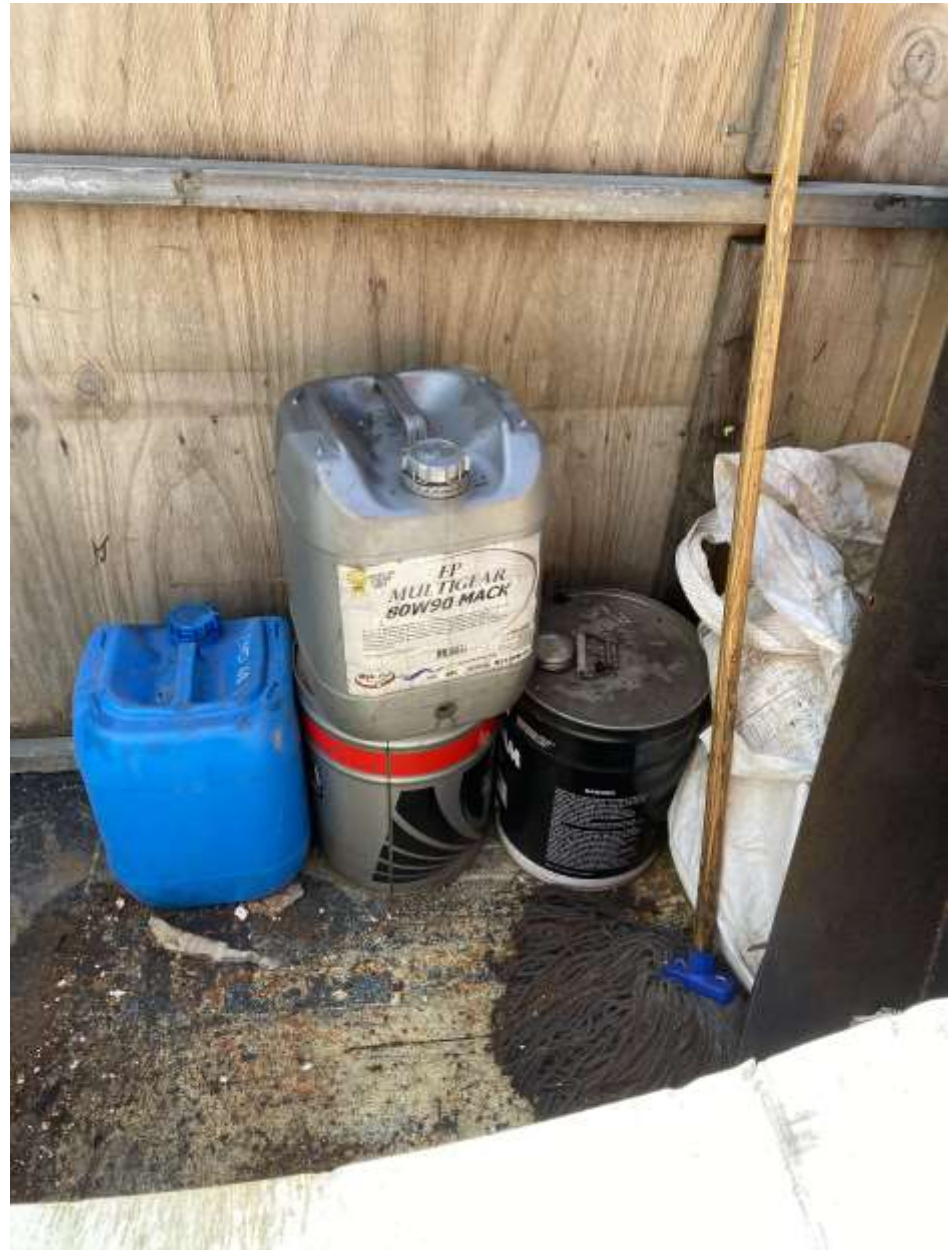
Item
13

Un
Bunded
un
labelled
fuel on
site
